MCFARLANE PARK

CPTED REVIEW

22 AUGUST 2024

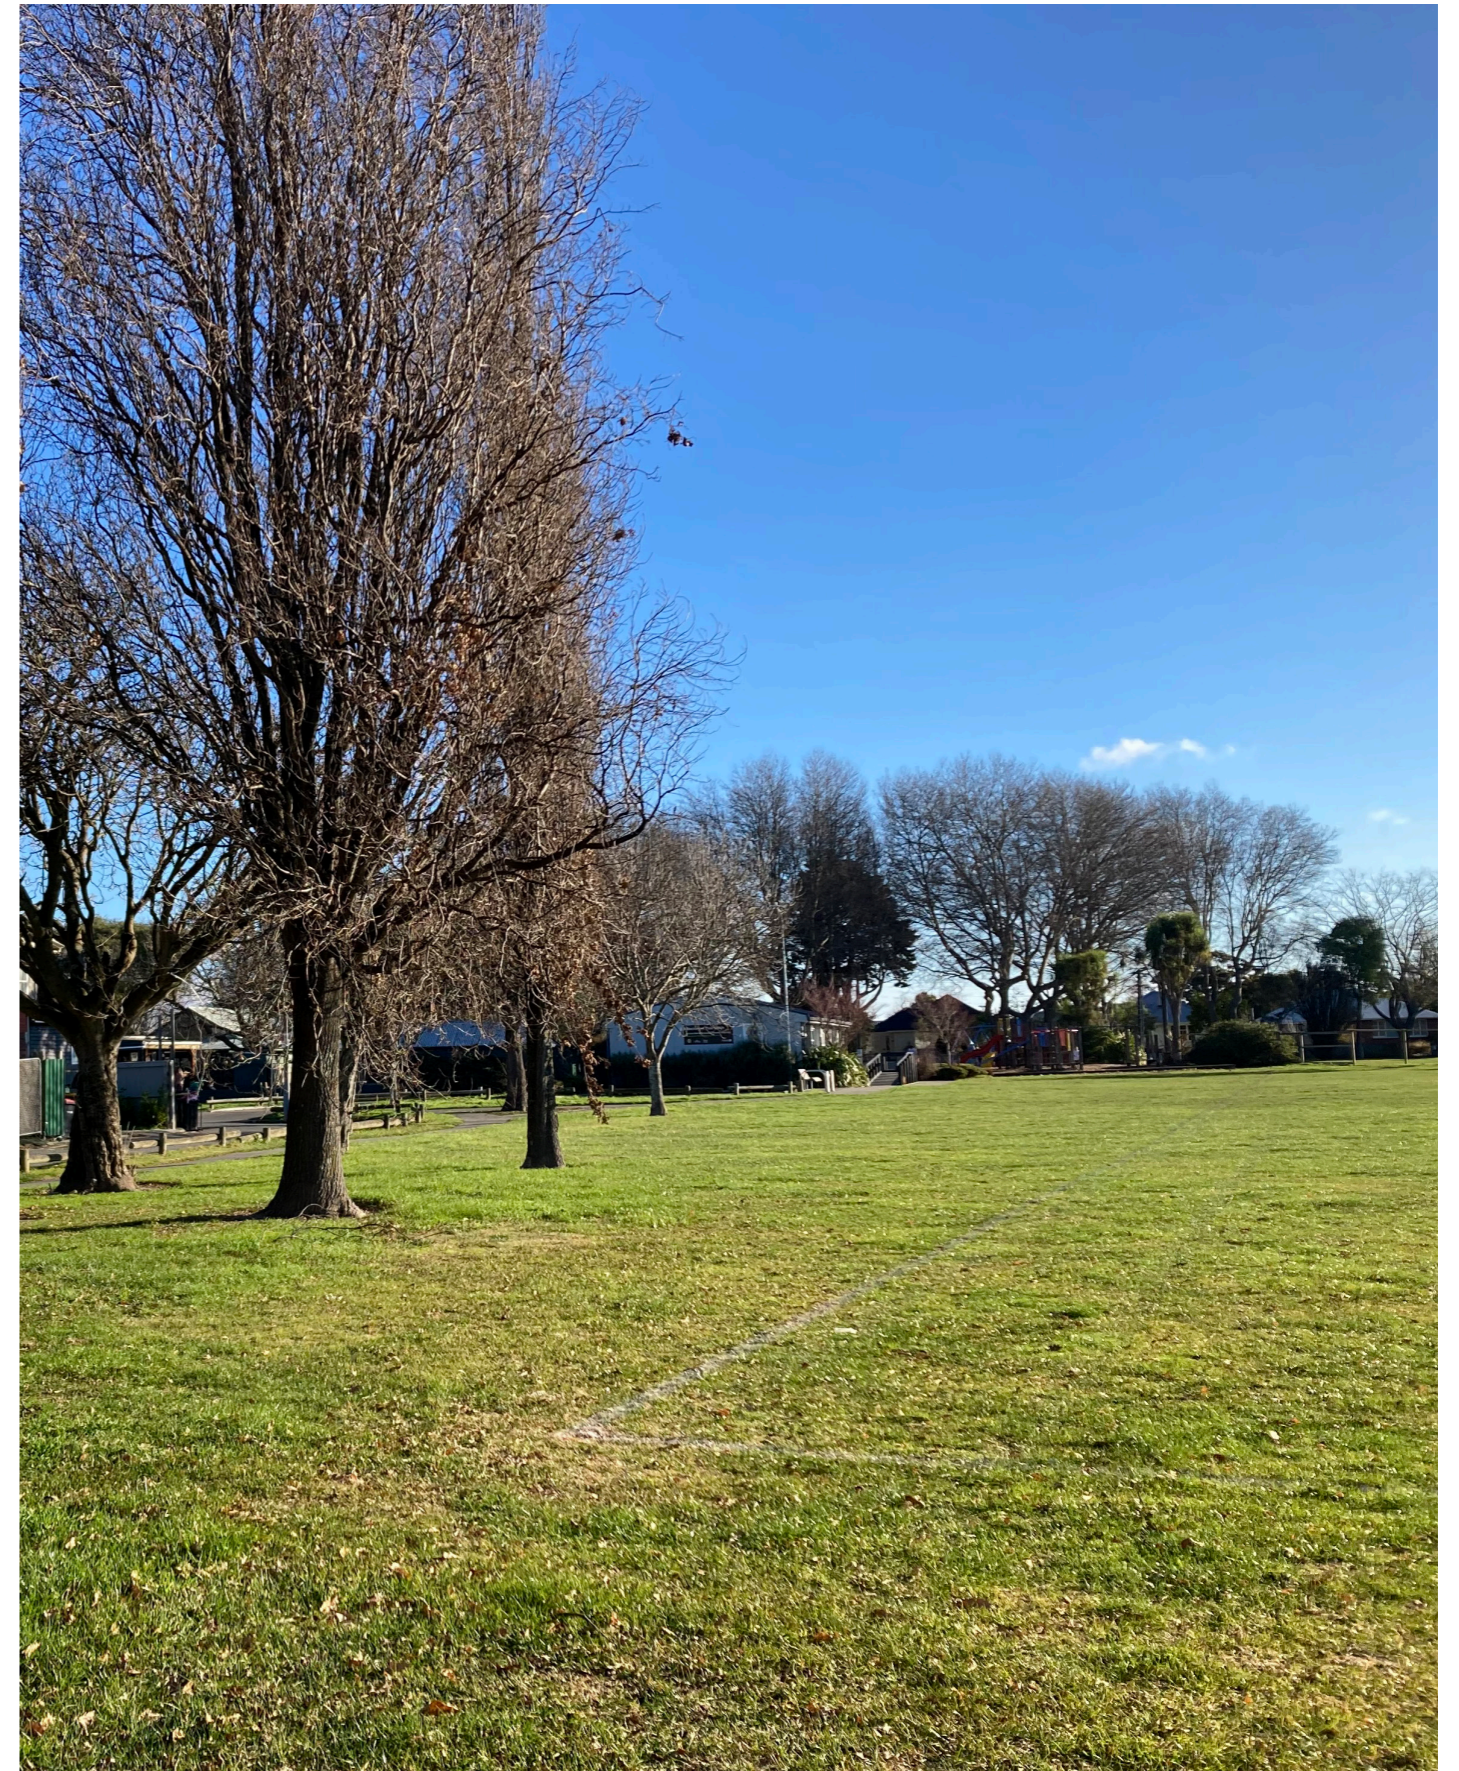
Figure 4: Photo of McFarlane Park showing the laneway with the community facilities in the background.

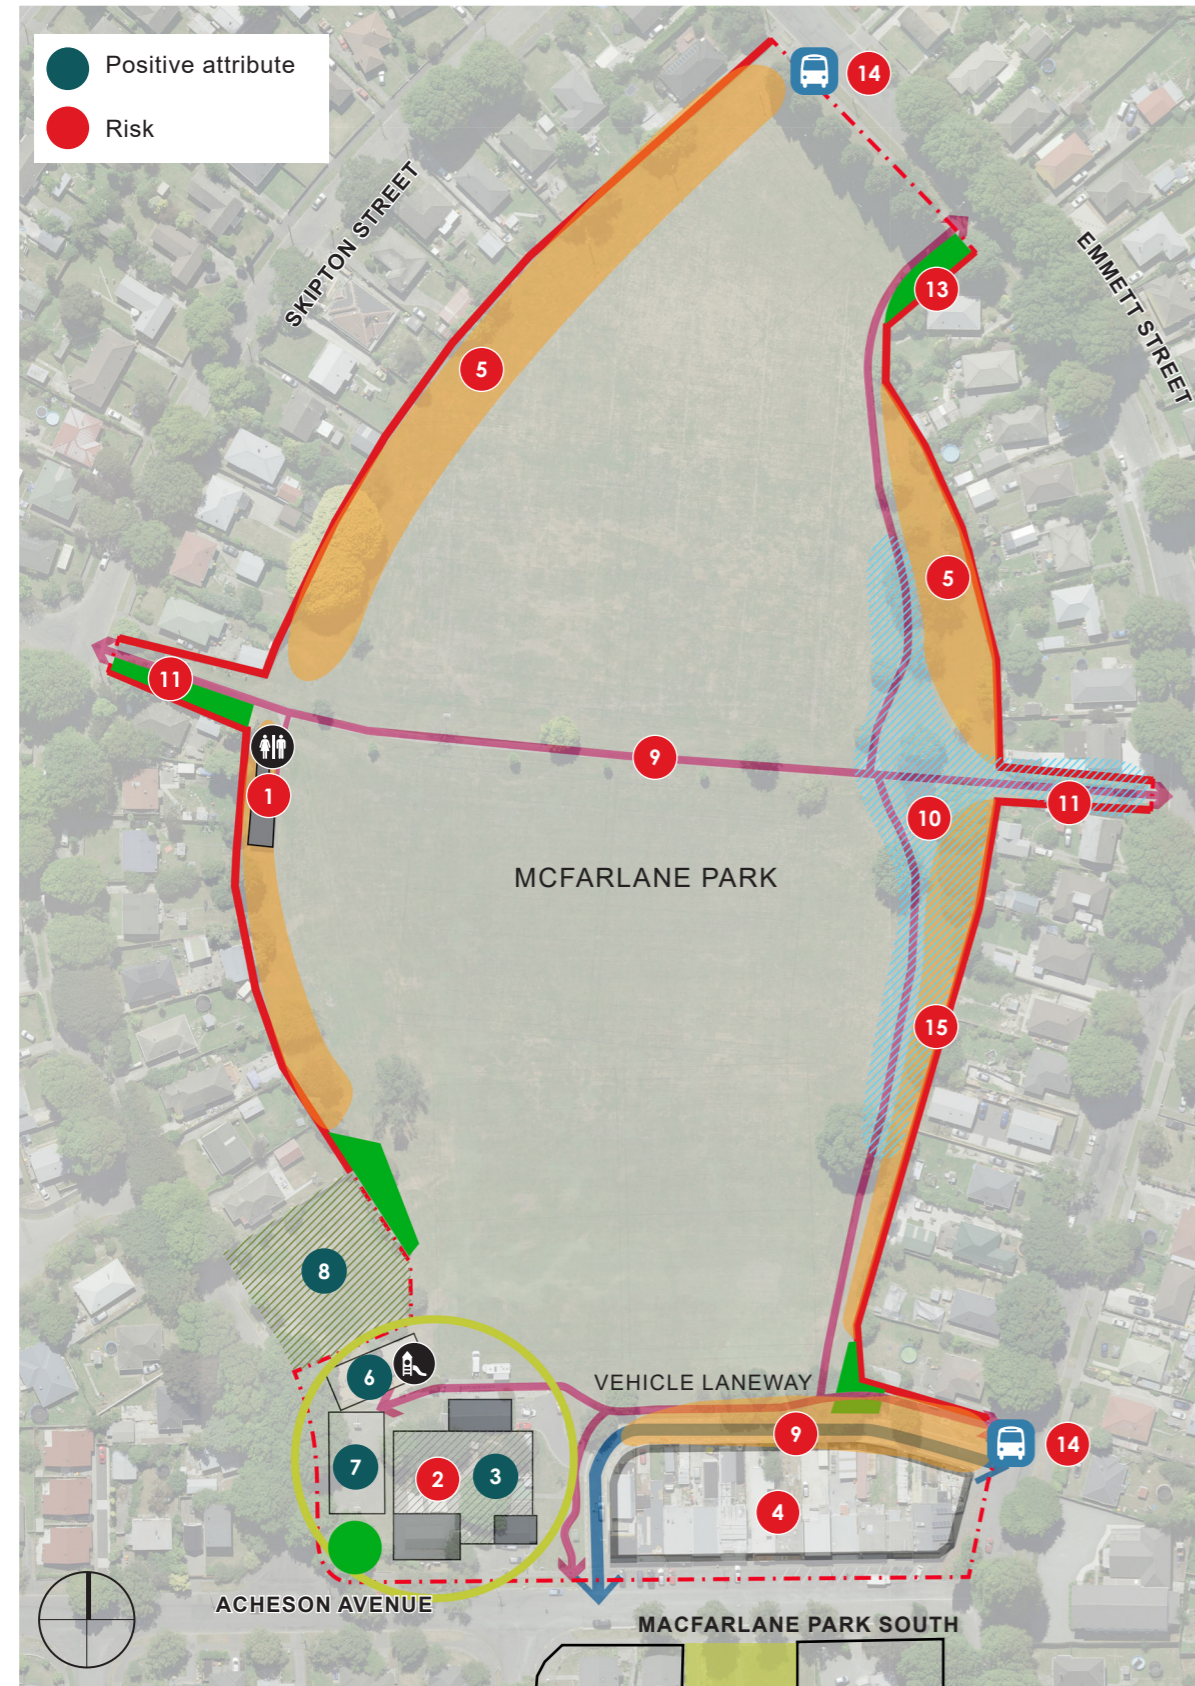
Figure 5: CPTED map summarising the Receiving Environment findings.

- 1 Public toilet and rugby storage shed**
- 2 Clustering of buildings limits views into park**
The clustering of the community facilities along Acheson Ave, with fences and vegetation in between limits views from Acheson Ave into the park.

- 3 Clustering of community facilities**
The clustering of facilities (including the playground and basketball court) with community building concentrates activation. Additionally, this area is well-served by public transport.

- 4 Inactive commercial area**
Empty shops which lack vibrancy and do not assist with supervision of the street.
- 5 Blind spots**
Due to the internalised nature of the park there are several areas which cannot be seen from the neighbouring houses, which creates CPTED risks.

- 6 Playground**
The playground is a much-loved facility and has good levels of supervision from Skipton Street and has significant potential for activation of the park. The playground will need renewal at some stage, however is it positioned too close to the residential boundary, making renewal in the same location not possible.

- 7 Basketball**
This is a well-used facility and has good levels of supervision from Skipton Street. This is one of the few youth-orientated facilities around this area and has significant potential for activation of the park.

- 8 Skipton Street property**
This empty Kainga Ora owned property opens out the views into the park.
- 9 Poor quality lighting of the mid path**
- 10 Flooding**
There are parts of the path which are regularly flooded after storms, making access challenging.

- 11 Proportions of the mid park entrance**
The proportions of the entrances to the mid-park connecting path and the fact that this route is a movement predictor, combined with limited supervision; results in CPTED risks related to entrapment.

- 12 Overgrown / over mature planting**
There are many locations throughout the park where vegetation is overgrown or over mature planting, limiting views.

- 13 Seat hidden in planting**
- 14 Bus stops with backs to the park**
The two bus stops adjacent to the park have their backs to the dark park.
- 15 Closed-board fencing**

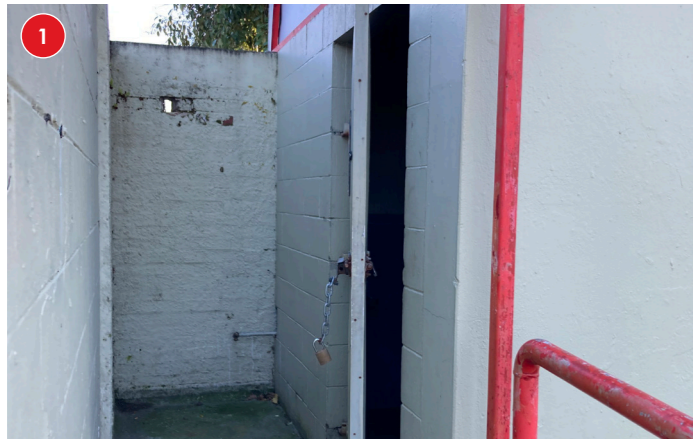
The location of these buildings has no passive supervision, nor is aligned with complementary facilities (such as a playground). The toilets are up for renewal in the next 5-years and this is evident with the poor quality of these facilities. The design of the building poses significant risks for entrapment, this risk can be serious in nature. There are also entrapment risks behind the toilet block/shed and evidence of rough sleeping and fire-lighting.

Existing public toilets in poor condition with entrapment risks.

<p>TOILET RENEWAL</p>	<p>Renew the toilets as a high priority. These toilets post a significant risk to the community.</p> <p>The current location is unsuitable and a new location should be considered which is co-located with recreational facilities such as the playground and basketball courts. The new location should be also visible from the street to ensure adequate supervision can be provided. This could mean that a temporary solution is implemented, with a long-term solution integrated with the facility being delivered.</p>

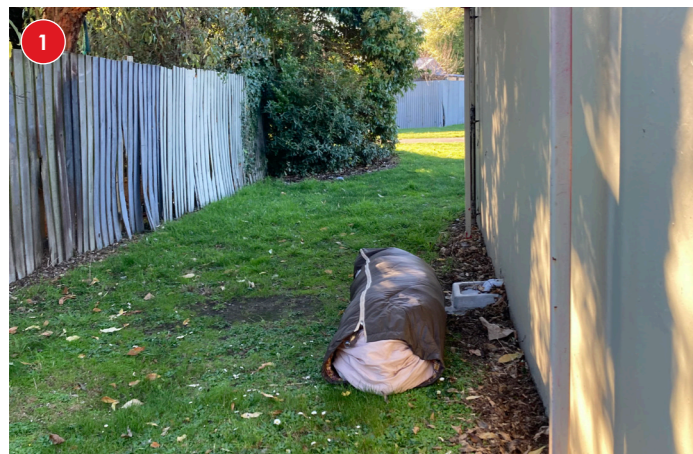
There is evidence and recall from locals of rough sleeping throughout the park, however this has not been a consistent or problematic theme.

Rough sleeping evidence at rear of public toilets.

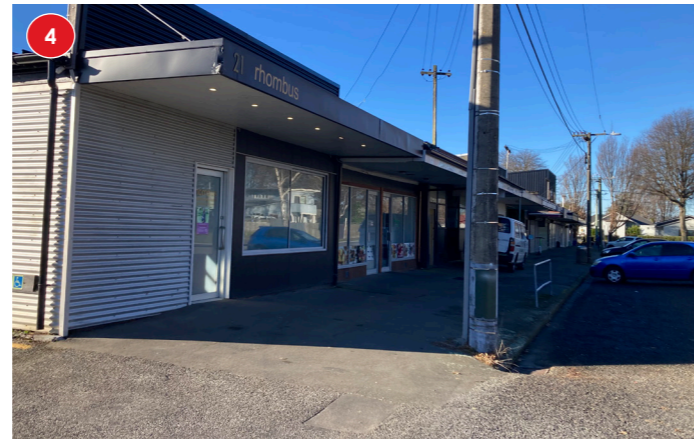
The commercial shops only have one 'active' shop frontage, the remainder are operating as businesses which do not have shop fronts. This has created a frontage which does not feel welcoming and has poor environmental quality. Some of the properties have people living in the back of the commercial premises, which is viewed in a positive light by locals in providing some supervision over the Park.

Acheson ave shop frontage with only one active shop to provide supervision.

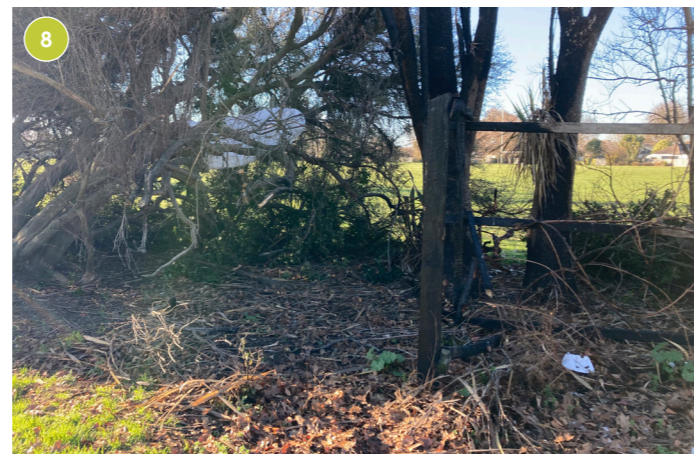
Evidence around the park of people lighting fires.

Fire evidence at skippton street properties.

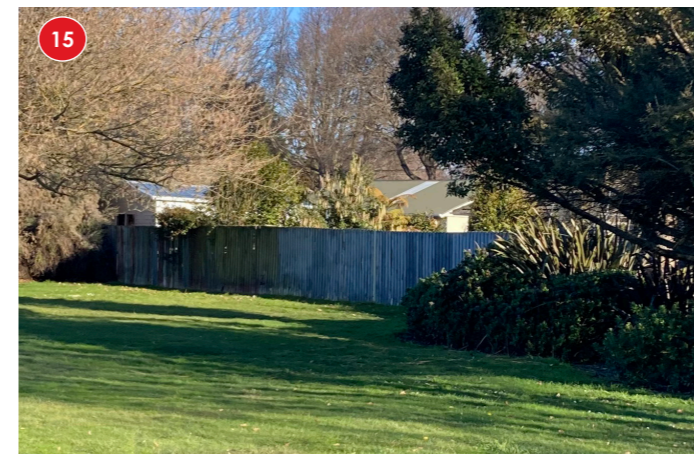
It is not possible to see through the fencing that surrounds the park, limiting supervision from neighbours. This is a missed opportunity as the houses are elevated and have potential to give oversight. This also creates blind-spots where there have been antisocial issues (noted in orange on the previous page).

Solid fencing and planting blocks views into park from houses.

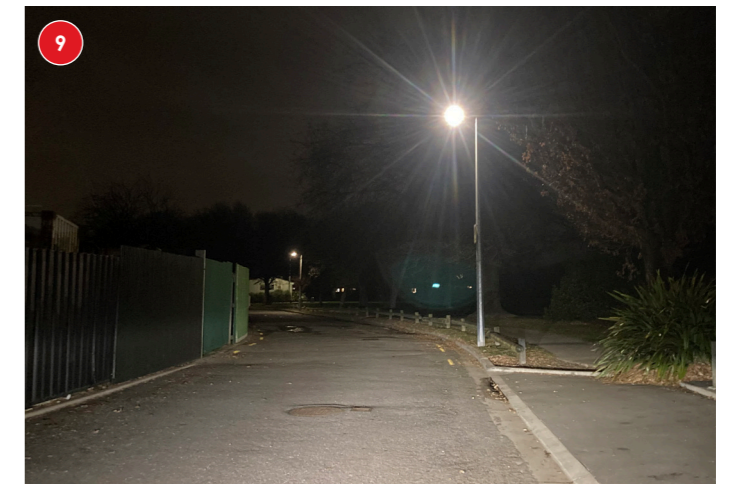
Lighting of the laneway is LED lighting and very bright, with luminaires pointed towards pedestrians, creating glare.

Glare created by led lighting in the laneway.

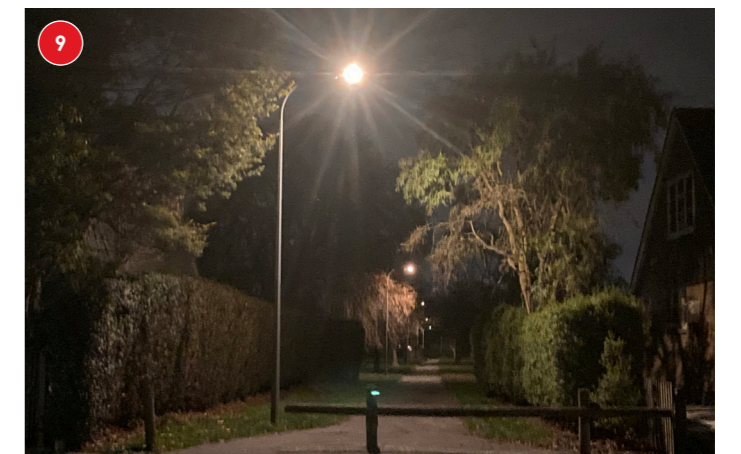
The central cross-park pathway has dated halogen lighting which creates glare for pedestrians and visual discomfort. The lighting has no grading in lux level and the highly lit path is very close to complete darkness, making offenders easily hidden.

Cross-park pathway lighting viewed from Emmett Street entrance.

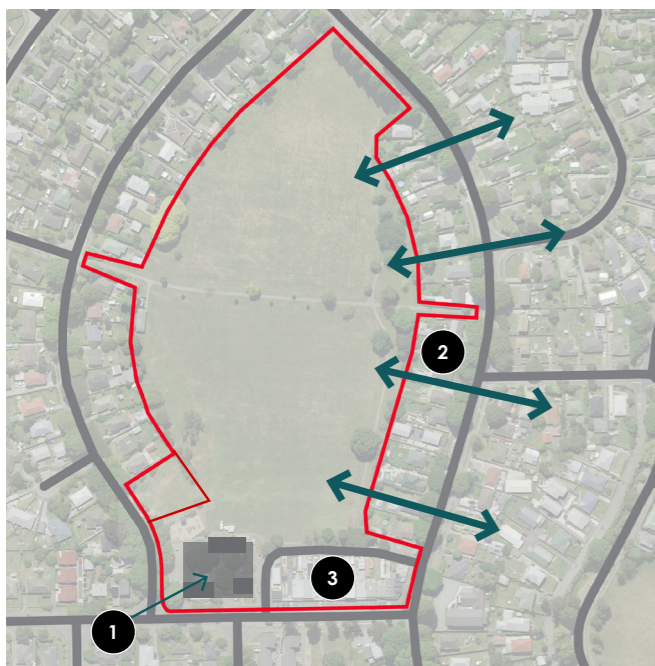
Figure 6: Diagram of possible options for opening up the Parks boundaries to improve supervision.

- 1 Consolidation of community facilities to open up towards Acheson Avenue in southwest part of site.
- 2 Land swap or land purchase options to open up the park towards Emmett Street, increasing proportion of the street frontage to the Park.
- 3 Investigating masterplanning opportunities for the Acheson Avenue shops, which currently have a front to the street and a 'back' to the park.

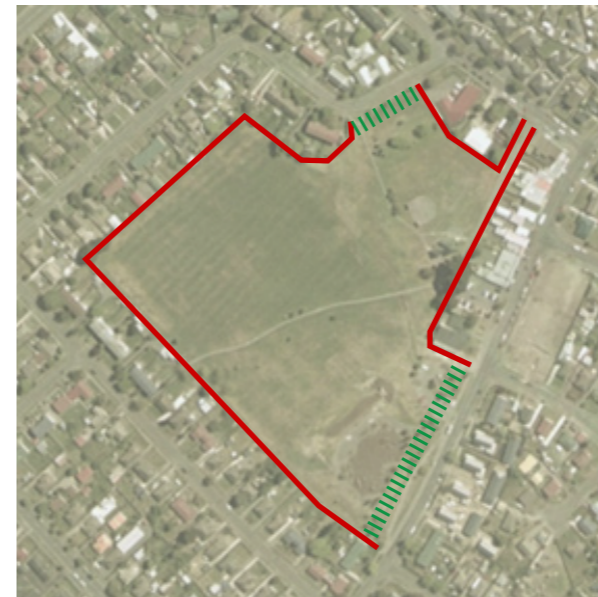
Wainoni park aerial image from early 2000's showing closed in park boundaries

Housing New Zealand and Christchurch City Council worked collaboratively to improve the safety of Wainoni Park. Land swaps along the north-west part of the site and the creation of a new road frontage significantly increased supervision over the park. This development significantly reduced CPTED risks in the Park. New community facilities (the Aranui Library and Community Centre) further activated the park and fostered community spirit.

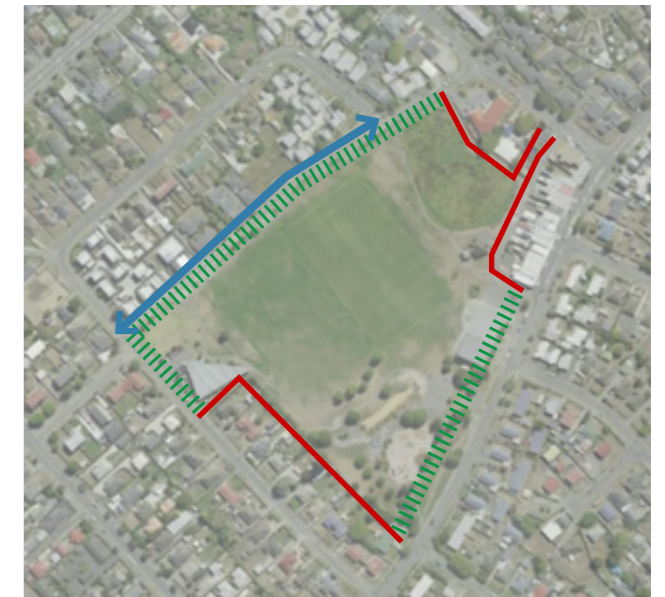
Wainoni park aerial image from 2023, land swap on north-west edge opened up the boundaries with new road added. (Source: linz)
